Case Report

Flexor Pollicis Longus Injury after Corrective Osteotomy of Distal Radius Malunion with Volar Fixed-Angle Plating: Case Report and Review Literature of the Flexor Tendon Injuries after Volar Plating

J Med Assoc Thai 2012; 95 (Suppl. 10): S213-S218

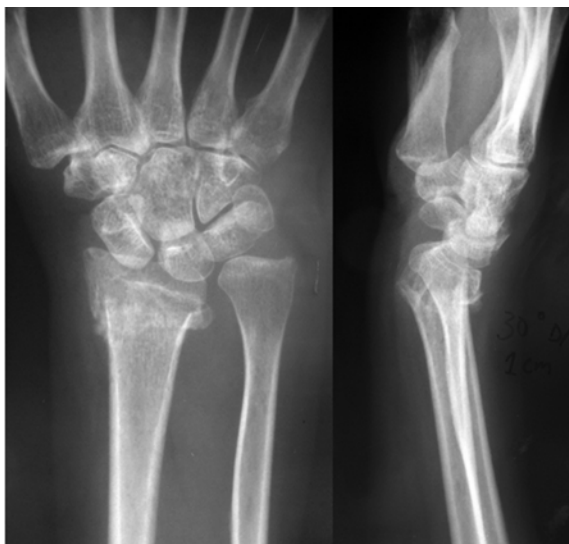
A 53-year-old right handed woman sustained a dorsally displaced distal radius fracture. She had a closed reduction and casting for 6 weeks. Physical examination revealed a right wrist deformity. Radiographic evaluation showed a nascent malunion of distal radius with 45 degrees of dorsal tilt, 10 degrees of radial inclination and 15 mm of positive ulnar variance (Fig. 1).

Fig. 1 Posteroanterior (left) and lateral (right) radiograph of the right wrist reveal a dorsally displaced extra-articular distal radius fracture. The fracture is closed to the “watershed” area and surrounded by a callus formation

After a routine volar approach and callus removal, the original fracture line and apex of the deformity were easily identified. Though the fracture line was close to the "watershed" area, the osteotomy was performed through the initial fracture line. A 2.4 LCP buttress plate (Synthes) was placed on the "watershed" area of the distal fragment because of the proximity of the osteotomy line and the area. Cancellous iliac bone graft was placed in the osteotomy site. The pronator quadratus muscle was not repaired due to the high-profile characteristic of the plate. Postoperative radiographs were satisfactory with volar tilt of 0 degree, radial inclination of 20 degrees and ulnar variance of 2 mm, however, the plate was not seated properly on the radius. The distal portion of the plate was elevated

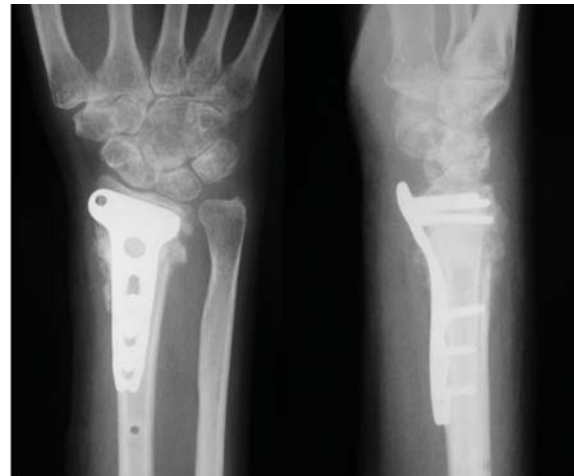
from the radial styloid (Fig. 2). The osteotomy site was healed at 8 weeks after surgery and the hand and wrist range of motion exercises were allowed as tolerated.

Fig. 2 Postoperative posteroanterior and lateral radiograph reveal an acceptable alignment of the distal radius. The plate was distally placed. The gap between the distal portion of the plate and radial styloid is noted

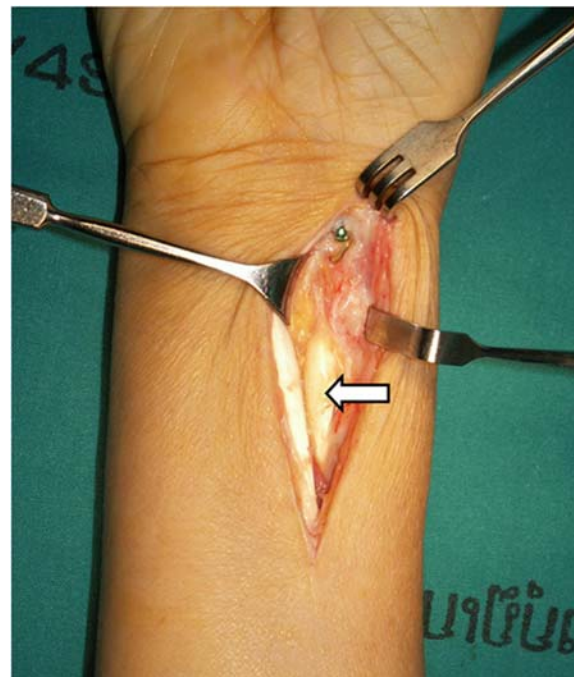
Surgical exploration revealed a complete rupture of the flexor pollicis longus tendon. The area of rupture was near to the level of prominent distal edge of the plate (Fig. 3). The flexor carpi radialis and flexor digitorum profundus were intact. The hardware was removed and the flexor pollicis longus tendon was reconstructed with ipsilateral palmaris longus tendon graft. Three months after the second operation, the pinch and grip strength were equal to the contralateral side. Range of motion of the thumb interphalangeal joint was 50% of the contralateral side.

Fig. 3 Intraoperative photograph shows flexor pollicis longus (arrow) ruptured near the distal plate edge

Malposition of the plate resulted in rupture of the flexor pollicis longus tendon in our patient. Placement of the plate beyond the 'watershed' area lead to prominent of the distal part of the plate distally and particularly on the radial aspect, combined with thickness of the plate both increased the risk of flexor tendon injury. As mentioned, injury is more vulnerable to more radial tendon-the flexor pollicis longus.

watershed area should be avoided if possible^(9,11,13,16). The pronator quadratus muscle should be repaired back after plating was successful^(9,13). The distal limb of the plate should be seated with the distal fragment as much as possible.

Finally, in the case of improper plate placement, the implant should be removed as soon as the bone is united because there were reports of tendon ruptures without warning symptoms^(11,13,17-19). Flexor tendon injury after proper plate placement has also been reported. In this group if patient experienced pain, swelling or crepitus over the plate, patient should return for plate removal without any hesitation.
